Case Study - Fatigue of Alternator Mounting Frame -

Arriva Trains, Wales, experienced 11 alternator frame failures over a period of 10 years.

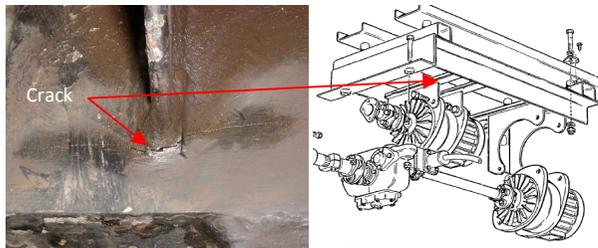
The fleet of class 150/2 trains operating on the GB rail network used alternators to provide an auxiliary electrical supply. The alternators were mounted on fabricated steel frame which had developed cracks in the main cross member over a period of time. Although no catastrophic failures had occurred; the failures discovered had the potential to develop further unless corrective action was taken.

Unbalance in the alternator rotation was assumed to produce cyclic stress at the welded joint which over long periods could cause fatigue fracture.

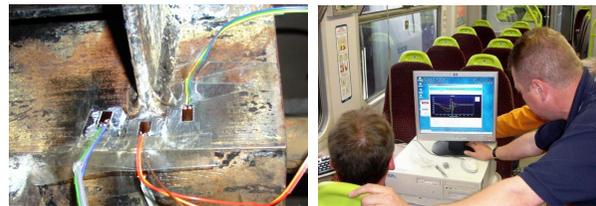
Based on the fracture characteristics, the orientation and location of maximum stress was identified and strain gauges fitted.

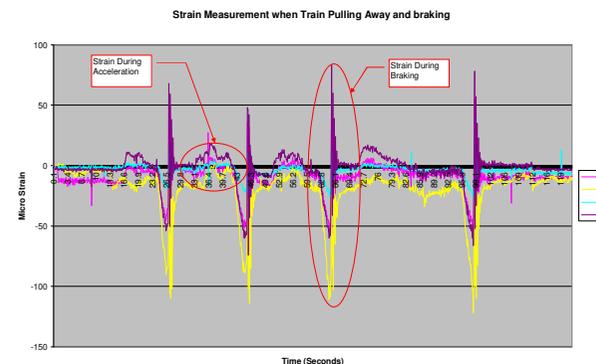
Strain gauge data showed that train acceleration produced stresses an order of magnitude greater than those caused by the vibration resulting from unbalance in the alternator rotation. The braking system was found to produce stresses a further order above those caused by acceleration.

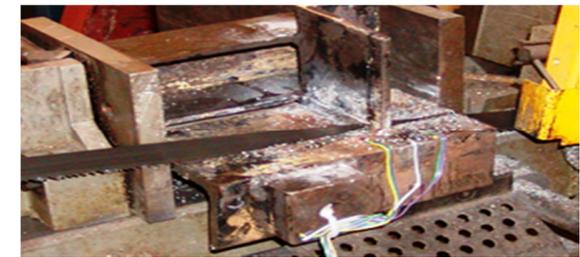
A portion of the alternator mount was removed and cuts made in the welded fillet. Strain gauge monitoring allowed the resulting stress relaxation to be evaluated.

Residual stress in the weld was found to account for 90% of the total stress experienced by the mount. The fatigue life corresponding to the total stress closely matched the predicted number of braking cycles required for fatigue to occur in trains in service. Stress relieving the welded joints was recommended to alleviate the failure problem.
